TEST REPORT FAÇADE SP FIRE 105

Name of sponsor:	NSF III UN17 Holding 2 ApS		
Product name:	UN 17 Village - Facade		
File no.:	PGC10009B	Revision no.:	0
Test date:	17-12-2021	Date:	03-02-2022
Pages:	9	Encl.:	38
Ref:	GWA	/ NOL

Examination of a façade cladding when exposed to fire.

SP FIRE 105, issue 5 – rev. 1994-09-09

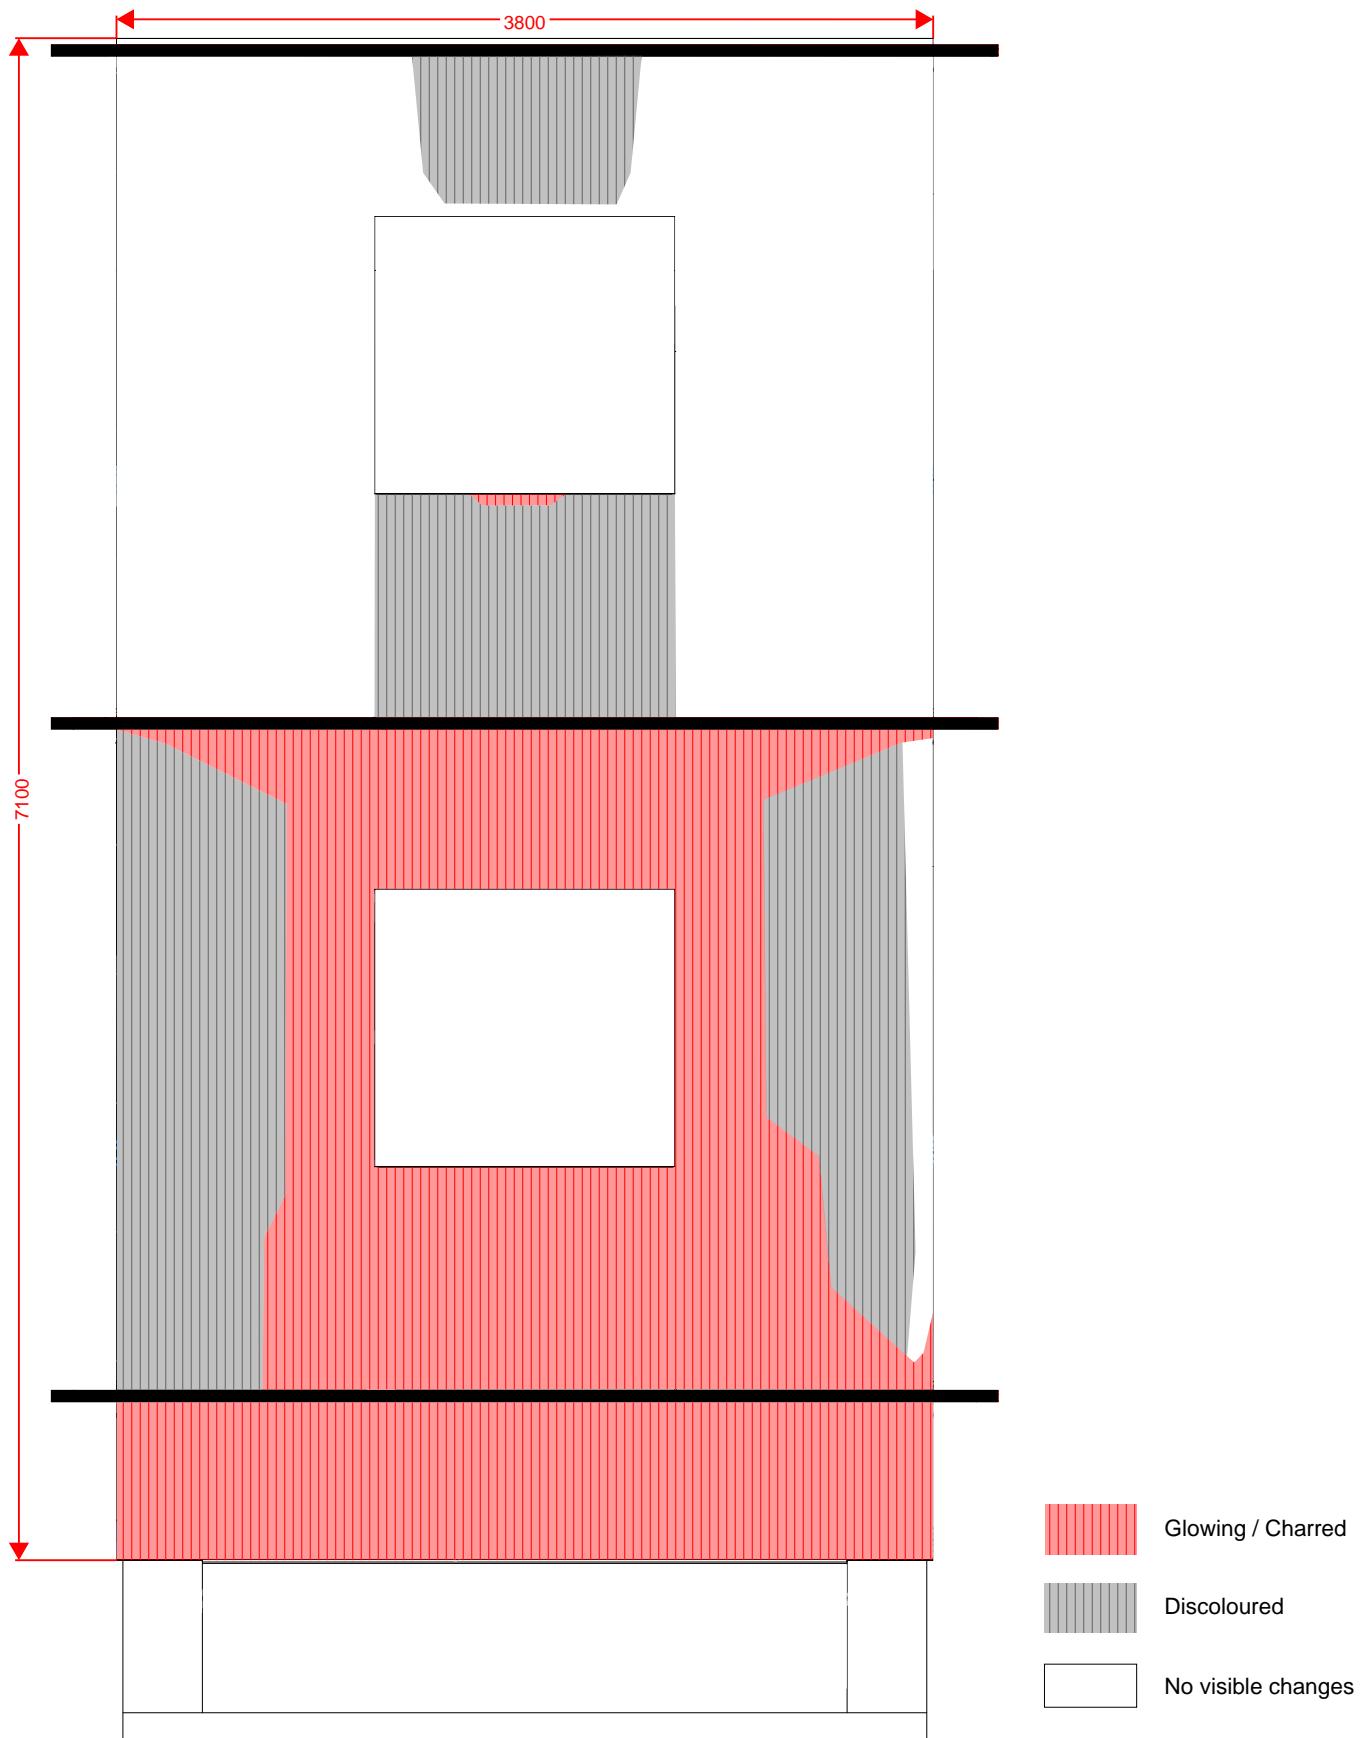
Enclosure: 1.0

Lots of charring and glow beneath 2nd fire screen
Some charring between the 2nd fire screen and 2nd window
No charring of timber outside the 2nd windows vertical steel profiles

Facade when all heptane was consumed

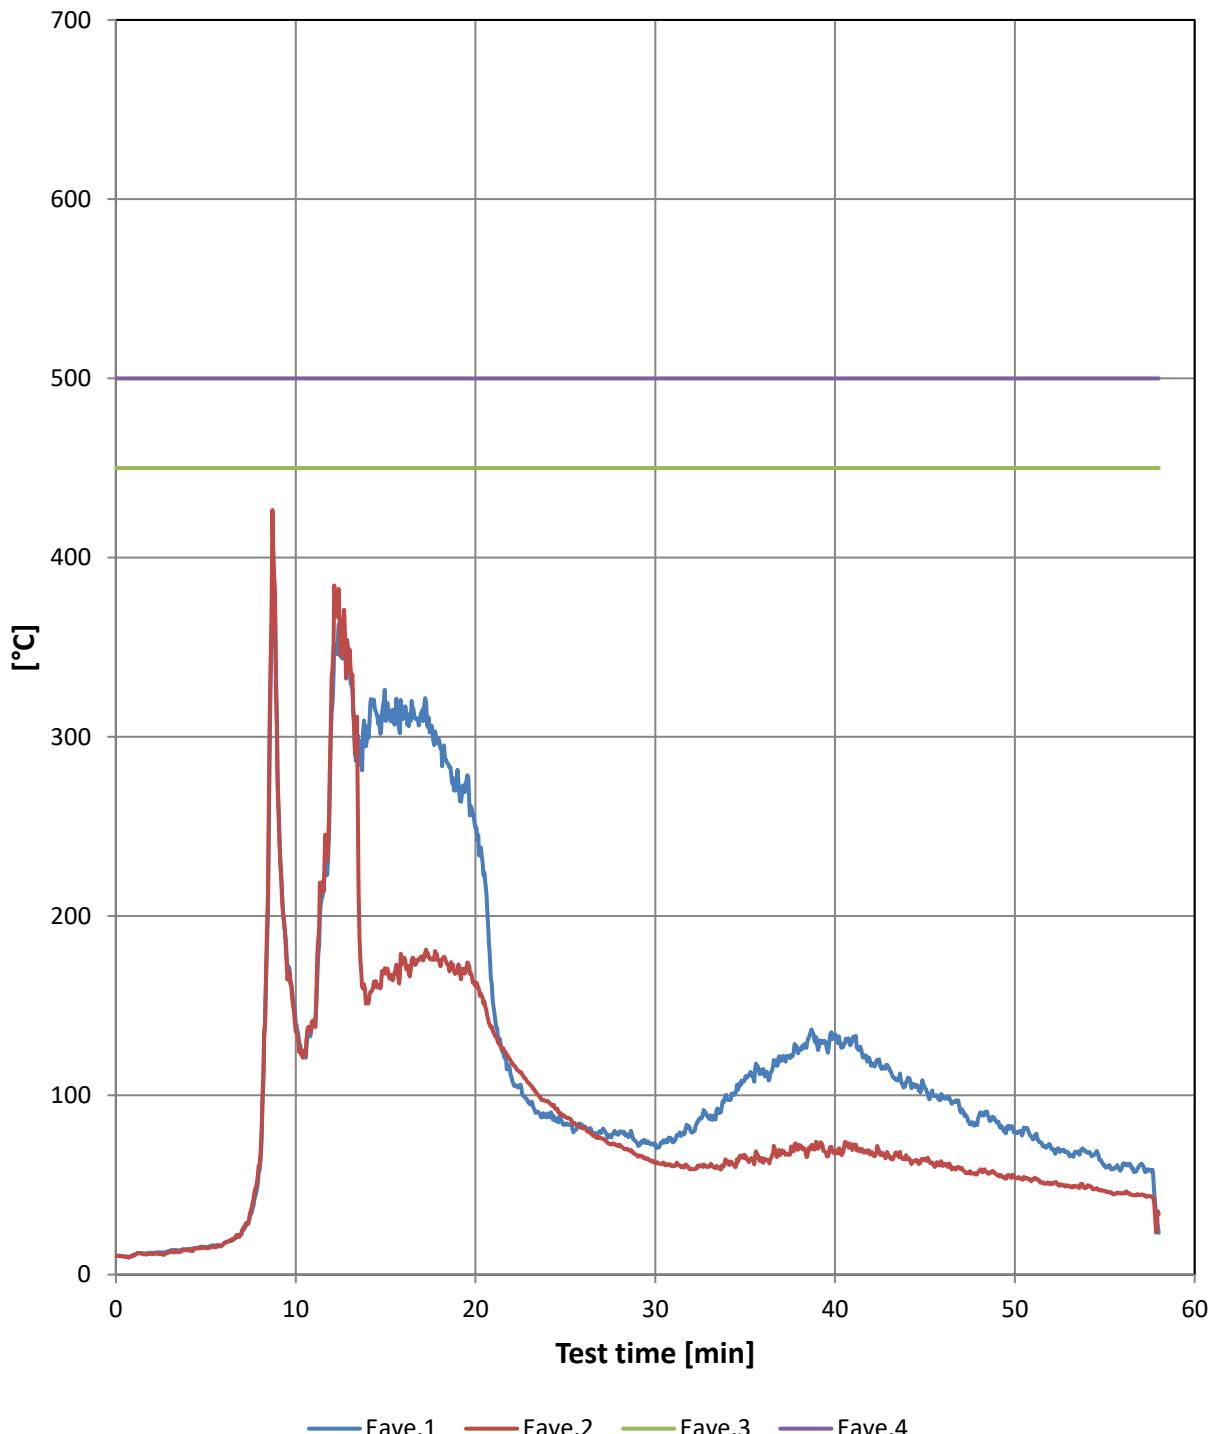
Temperatures under the eave

Eave.1/2 was not over 450 °C

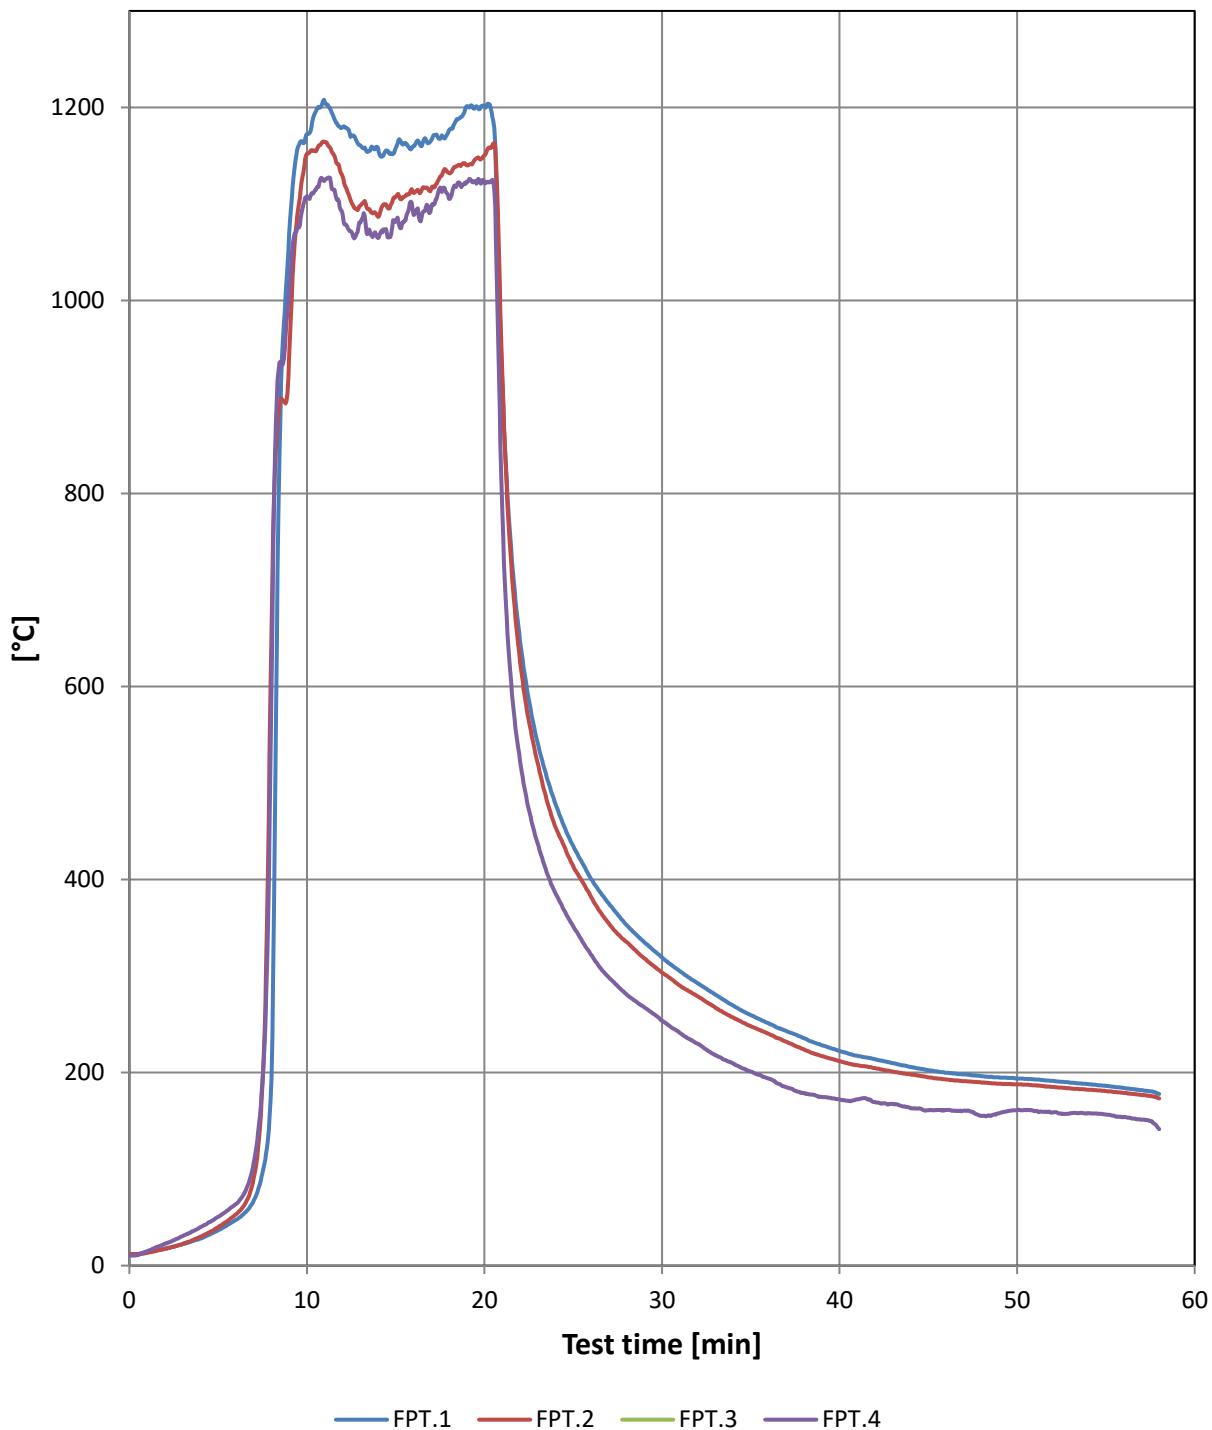
The temperature in the fire chamber during the test

FPT.3 malfunctioned before the test

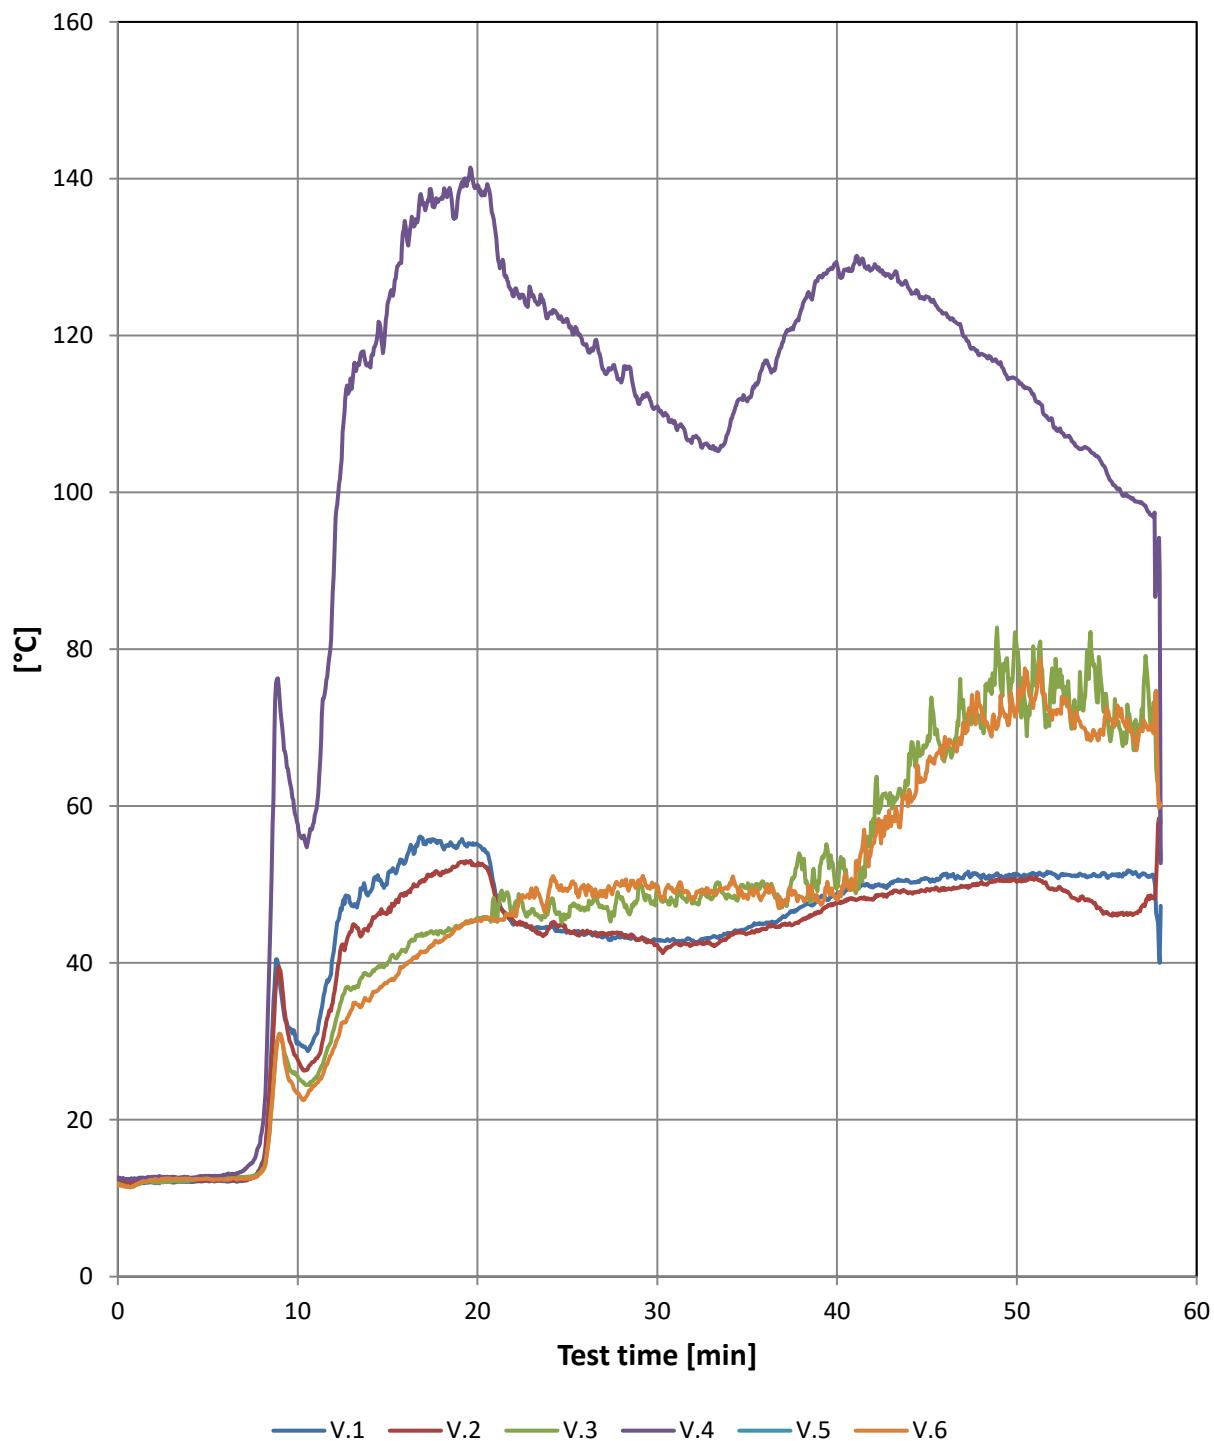
The temperature in the ventilated air gap in the top floor

V.5 malfunctioned before the test

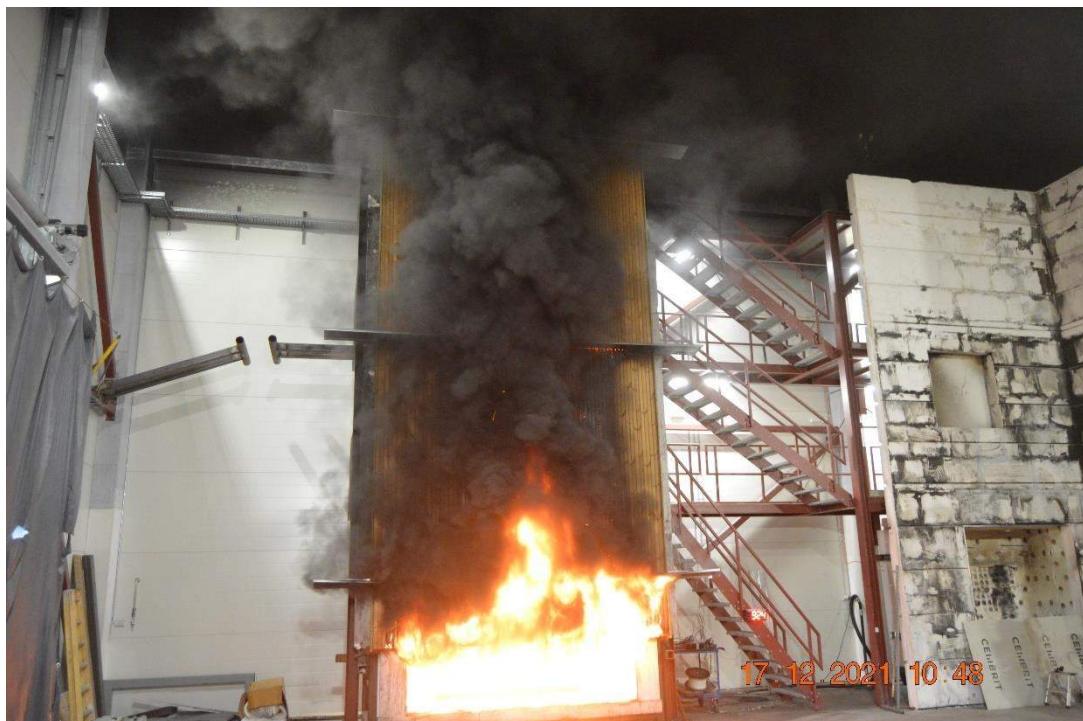
Photo No. 11 Glow below 2nd fire screen after 9 minutes of testing

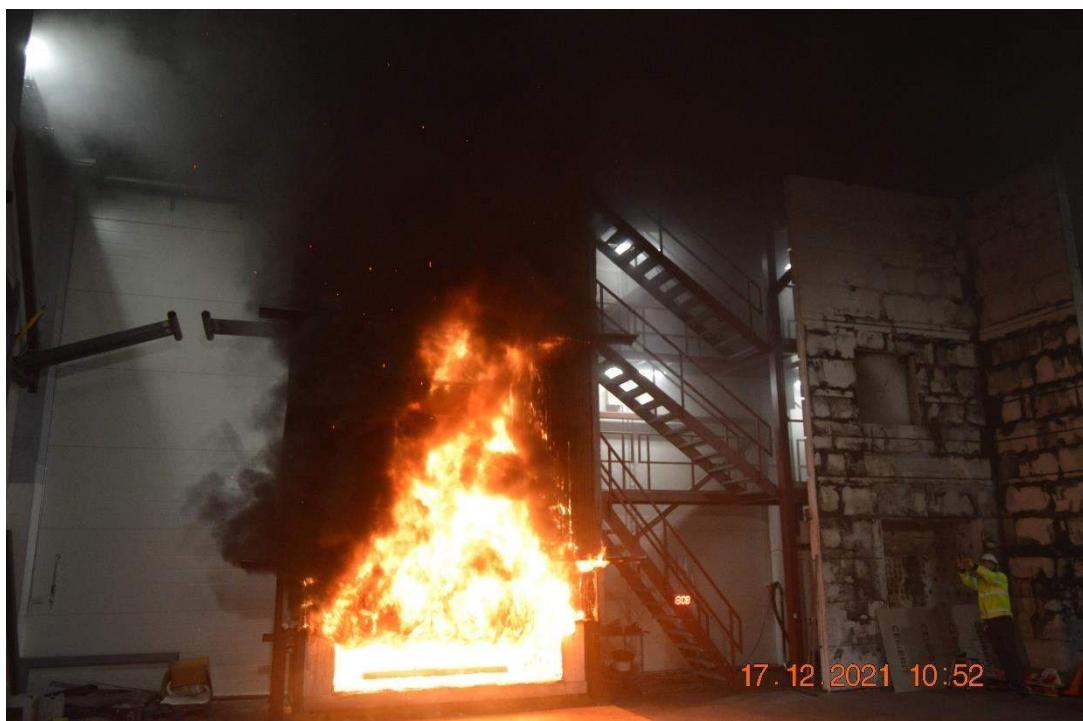
Photo No. 12 Vertical flame spread out to wall edge below 2nd fire screen after 13 minutes of testing

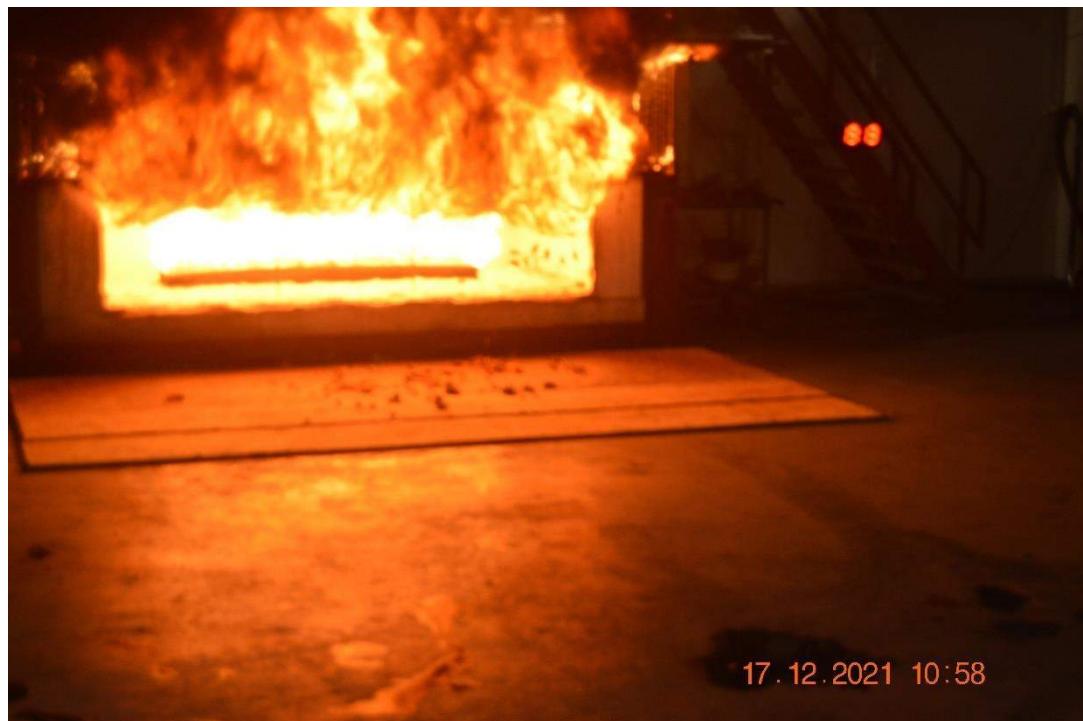
Photo No. 13 Small debris starts falling after 18 minutes of testing

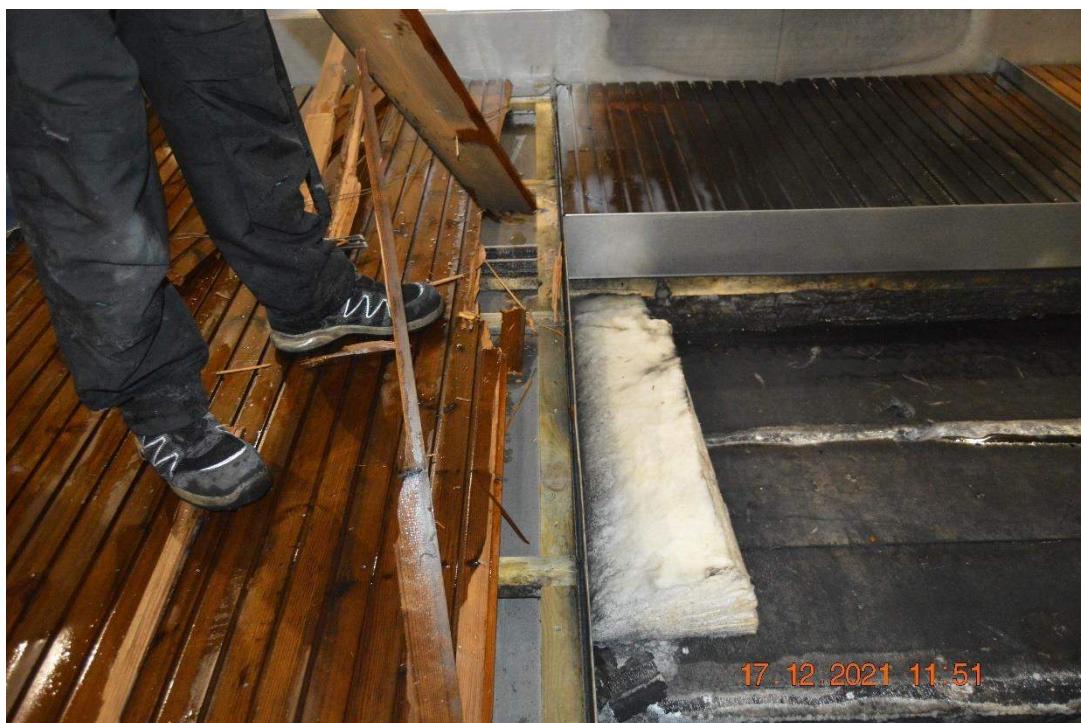
Photo No. 22 Timber on the right side of top window

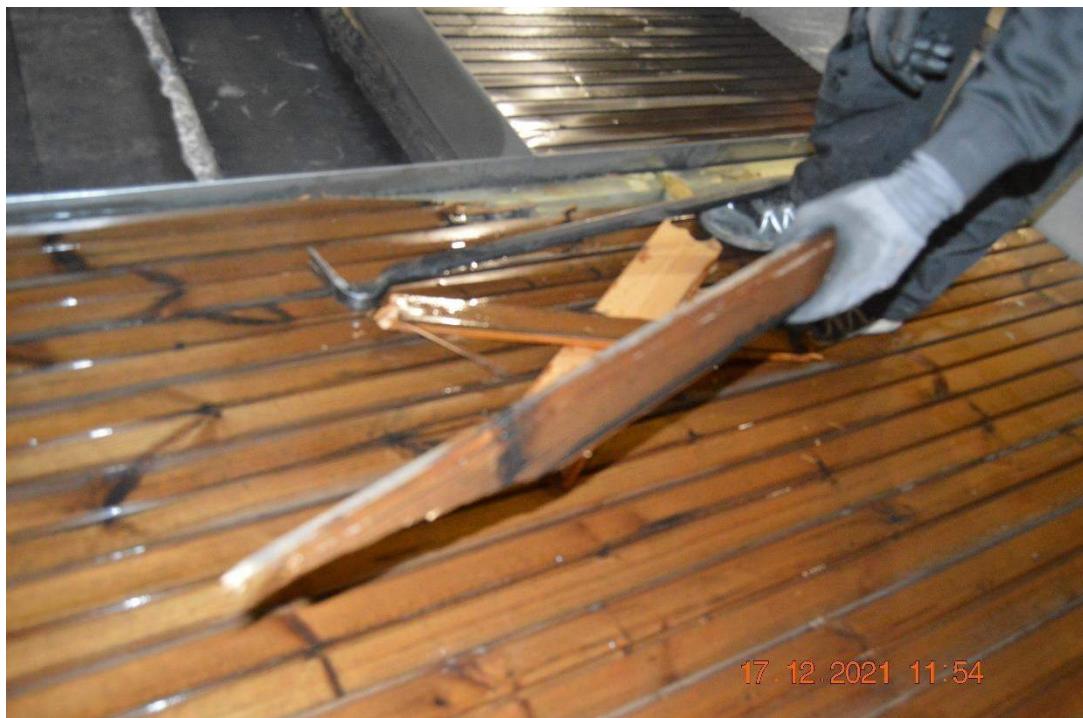
Photo No. 23 Timber on the left side of top window

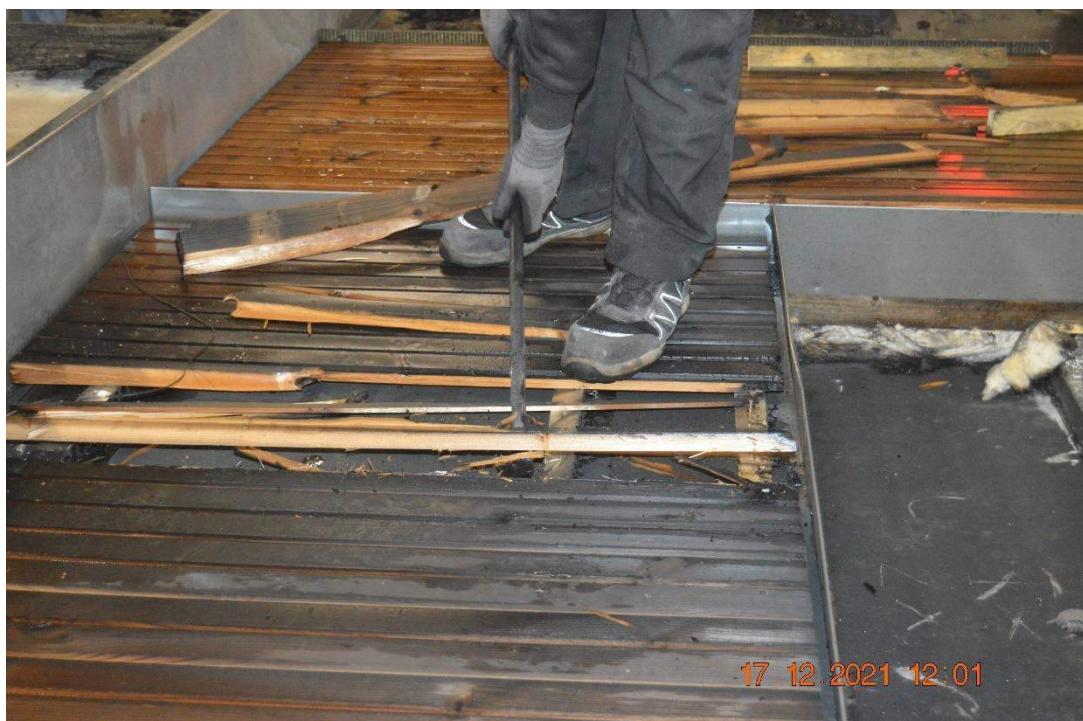
Photo No. 24 Timber with charring below the top window
